EAST WINDSOR WATER POLLUTION CONTROL AUTHORITY

MAY 2010 COLLECTION SYSTEM MAINTENANCE

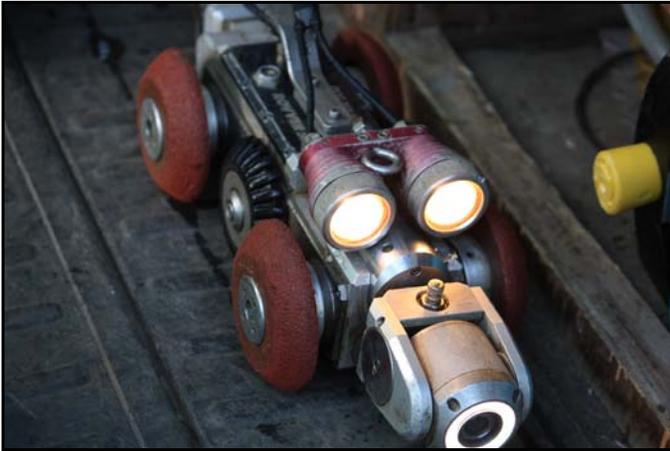
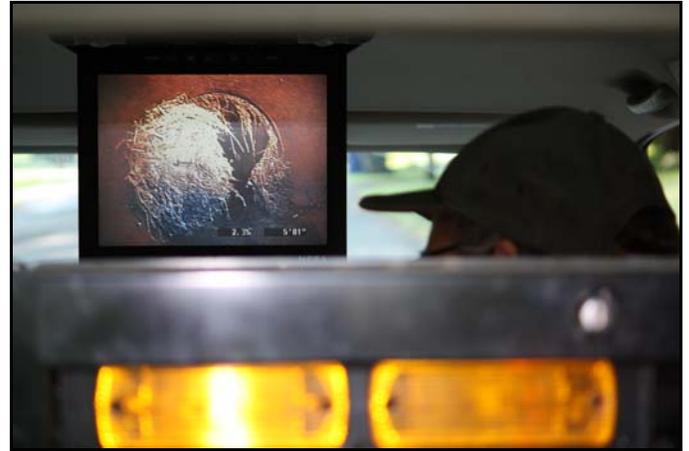
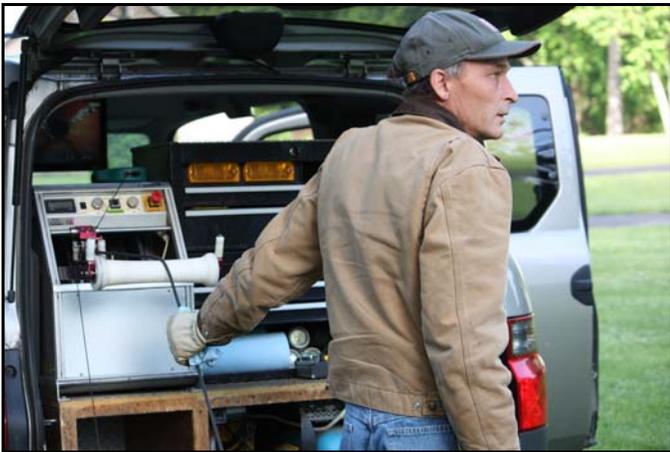
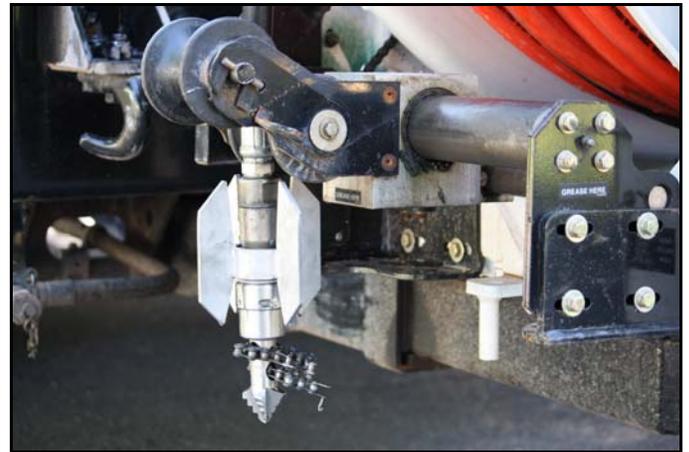
Photos from Mobile Robotics, Clockwise from upper left: Severe Roots. Severe Grease and Broken Pipe.

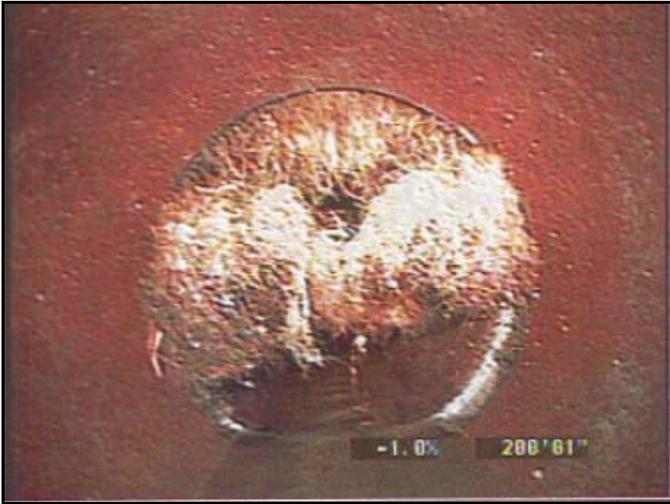
The complete length of Pleasant Street was inspected. The system consisted of 8" clay sanitary sewer pipe. What was found consistently throughout this length of pipe was a series of minor sags and offset joints. Severe roots are visible blocking the line at several sections. There is broken pipe at a few locations. Toward North Main Street severe grease buildup is evident within the line.

Plant Operators were able to use the visual provided by the camera, as well as the experience of Charles Brown of Mobile Robotics, to flush and cut through much of these sections of pipe. Knowing what you are up against allows our operators to choose the correct head for the flushing mechanism. Having this knowledge also gives them the confidence to send in the root cutter, something which is frowned upon without first "seeing" the pipe.

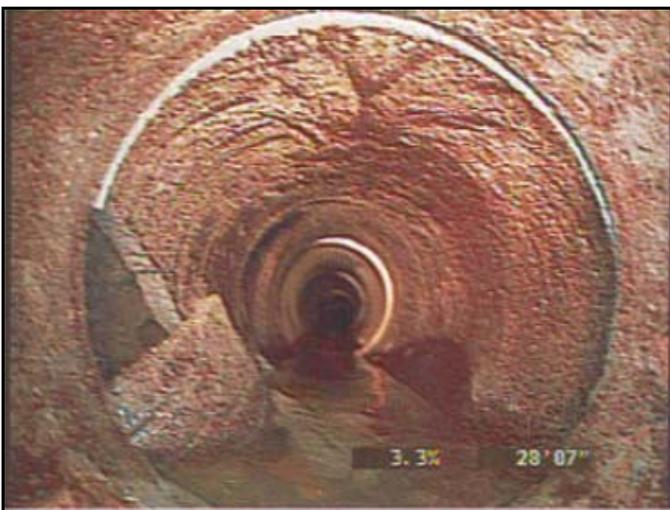
The section of sanitary sewer line from the intersection of Pleasant Street south along North Main Street has been an ongoing issue for us. This was revealed to be 10" clay sanitary pipe. Unfortunately, severe grease, roots and debris were seen within the first 50' section, with the camera unable to continue within this section without more thorough cleaning. This is a 600' run without an intermediate manhole. Useful information gathered thus far includes the need for an additional manhole at some date, along with the warning to not use the root cutter on the jet flushing mechanism until more of the line can be viewed. The fear is that by cutting "blind", we could end up plugging the line downstream as we would not yet know what the condition of the pipe is.
