Reference: Broad Brook Mill - Building 11 - Opinion of Structural Conditions

The Broad Brook Mill complex consists of five remaining structures, including Buildings 5, 11, 17 and 25, after a fire destroyed a majority of the buildings in 1986. The author has been engaged to provide an opinion of structural condition for Building 11, constructed in 1882 for the purpose of wool storage.

The author visited Building 11 of the Broad Brook Mill complex on October 23, 2018 to visually assess its condition. The following report contains a summary of findings. For the purposes of this report the front elevation of Building 11 faces south, while the rear that borders the northern edge of the site and the Broad Brook faces north.

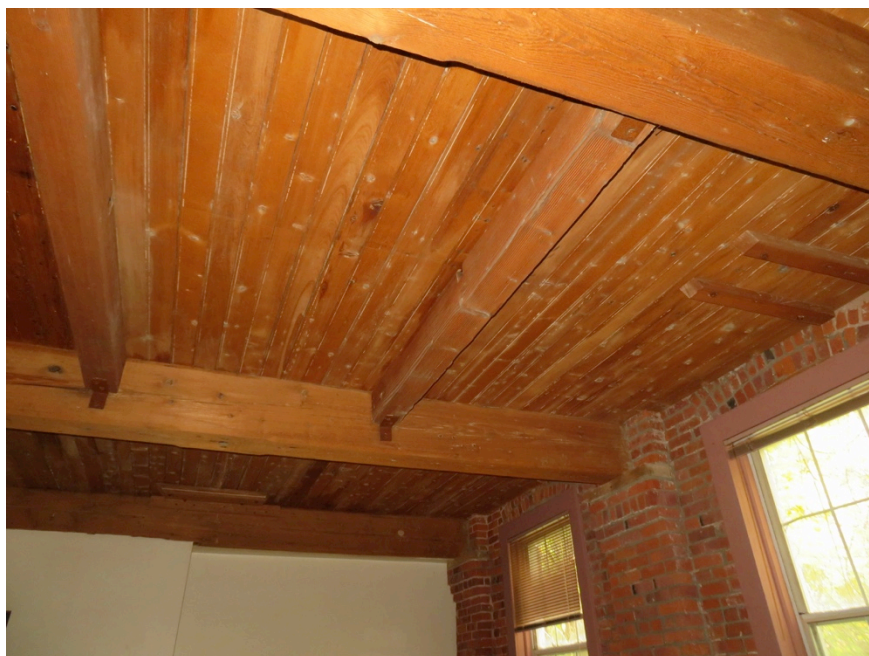
- S-1** Interior Roof and Floor Framing, general condition. The interior roof and floors are framed with heavy timber “slow burn” beam and structural wood decking. Most remain exposed as architectural elements within the units and appear to have been sandblasted during the 1990’s conversion. Iron wall ties connect the beam ends through the wall to an exposed decorative element on the exterior; an important structural element for meeting contemporary seismic codes. The majority of the framing appears to be sound and capable of re-use, with the exception of the items below.

View of Typical Second Floor Framing

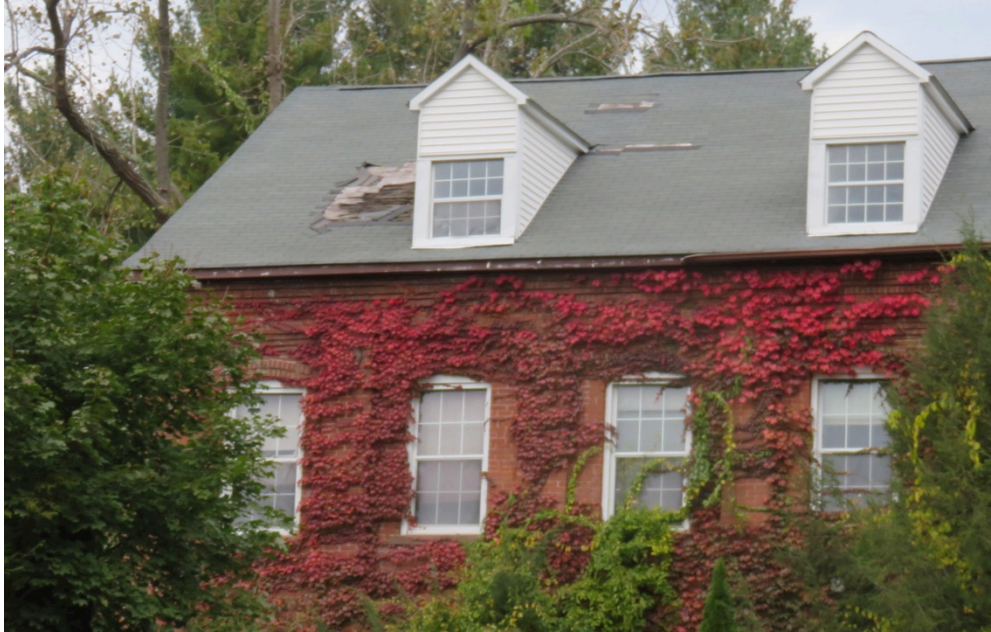
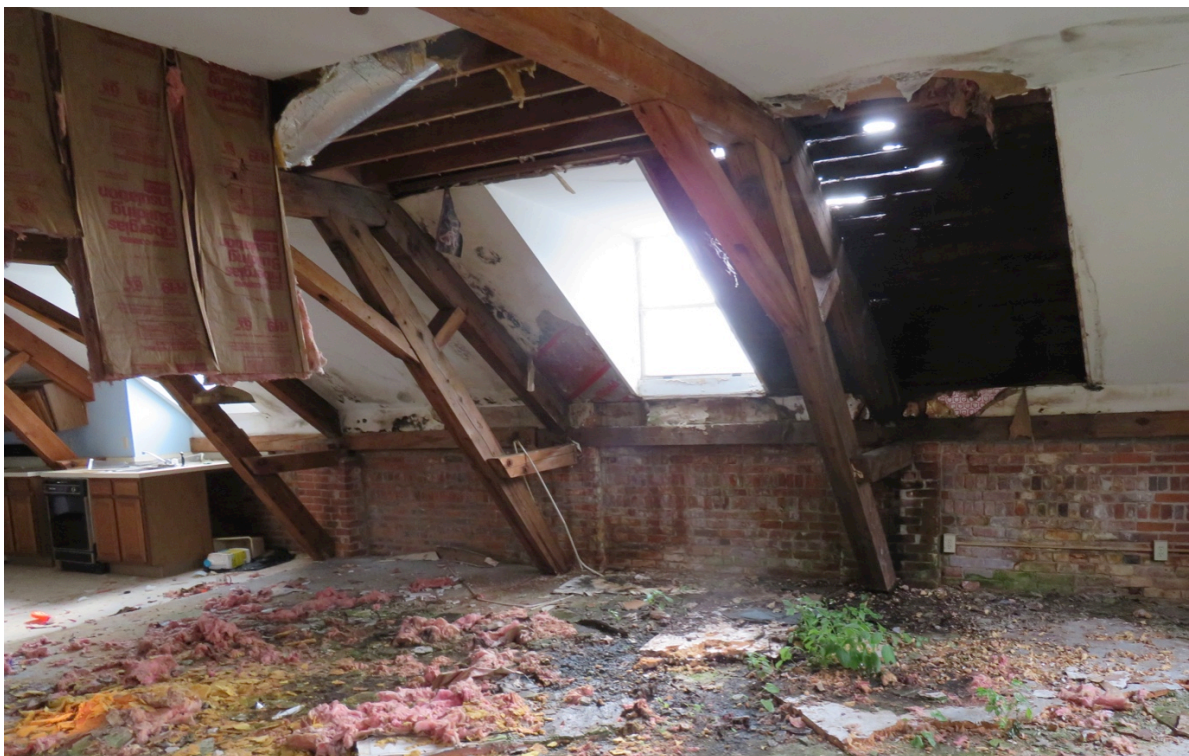
- S-2** Roof Breach at West End, South Slope. A roof breach at the west end has allowed water to infiltrate the building causing local deterioration of the roof and floor framing below. The breach has also been a source of moisture fueling the mold growth noted in item S-5 below. *Deteriorated roof and floor framing will need to be examined more closely after finishes are removed to determine extent of damage. Decking and sheathing local to the leak will most certainly need replacement, and at least one roof truss and floor beam will require replacement or significant reinforcement. In the short-term, we recommend that the breached area be covered to minimize additional damage to the area.*

Exterior and Interior Images of West Roof Breach

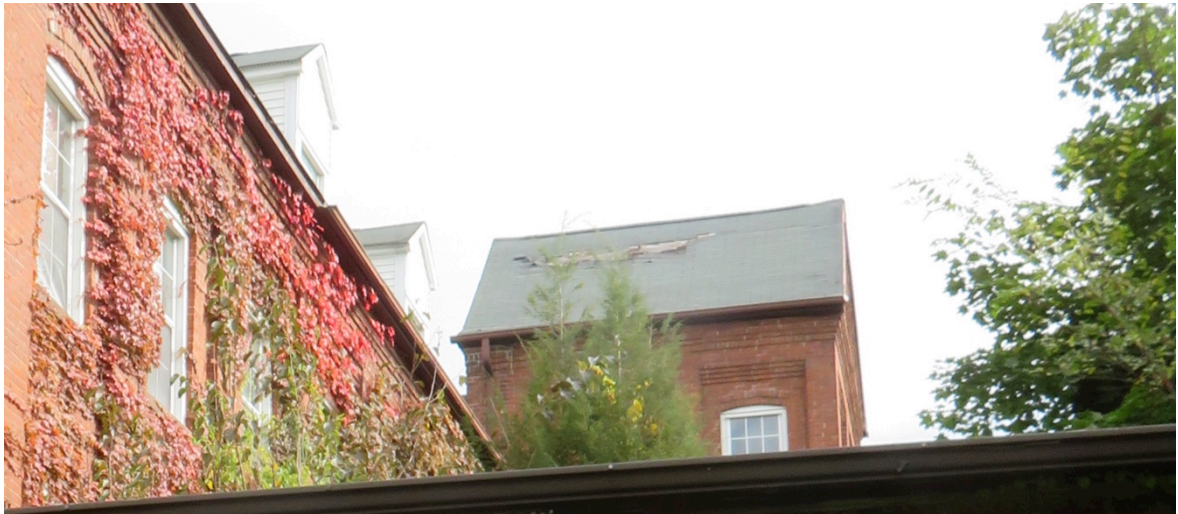
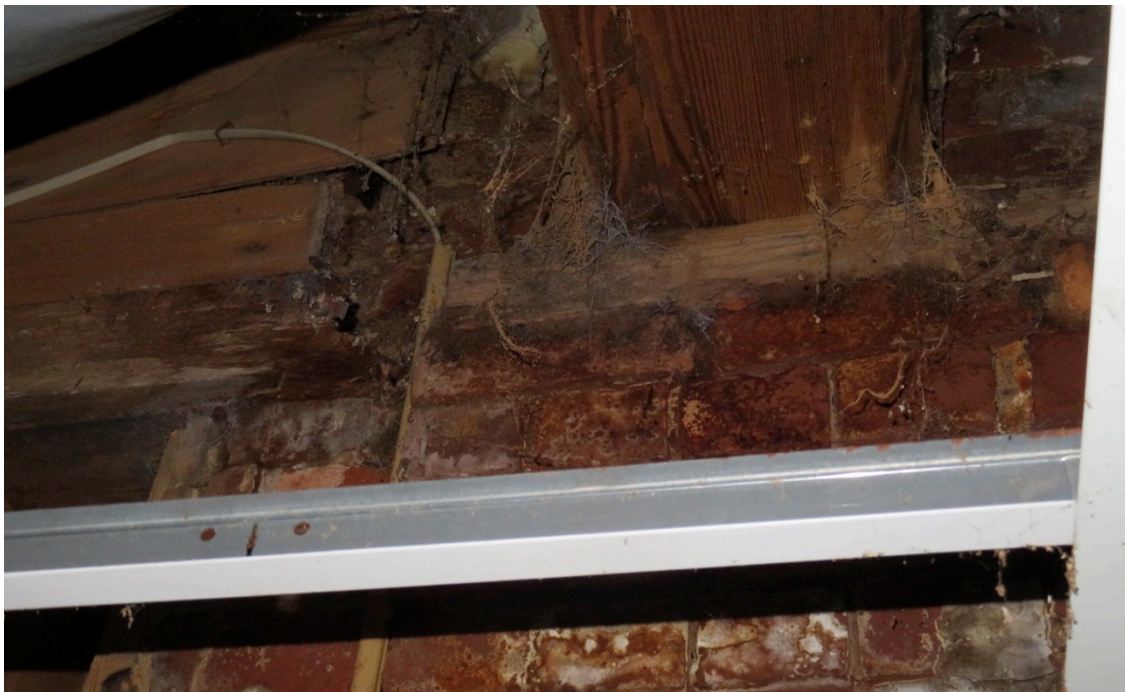
- S-3** Roof Breach at West Slope of Stair Tower. A second roof breach was identified at the west slope of the stair tower. This breach has also caused local framing deterioration and provided a moisture source for the mold. *Deteriorated roof and floor framing will need to be examined more closely after finishes are removed to determine extent of damage, and damaged section replaced. In the short-term, we recommend that the breached area be covered to minimize additional damage to the area.*

Exterior and Interior Images of Stair Tower Roof Breach  
Interior image shows a water-stained wood beam bearing on brick wall

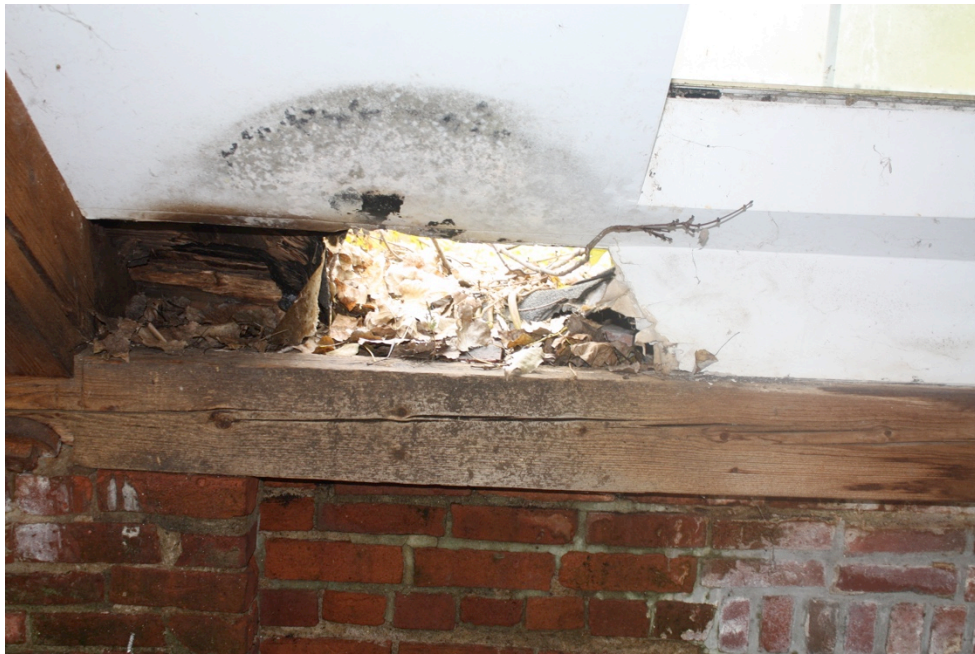
- S-4** Cornice Breaches, West End. A few breaches in the wood cornice at the west end of the building were identified, possibly caused by rodents. The openings have lead to local deterioration of the top wood plate and rafter ends. *Local replacement of wood plate, reinforcement of rafter ends, and rebuilding of the cornice will be required.*

Interior Images of Opening at Cornice Breach

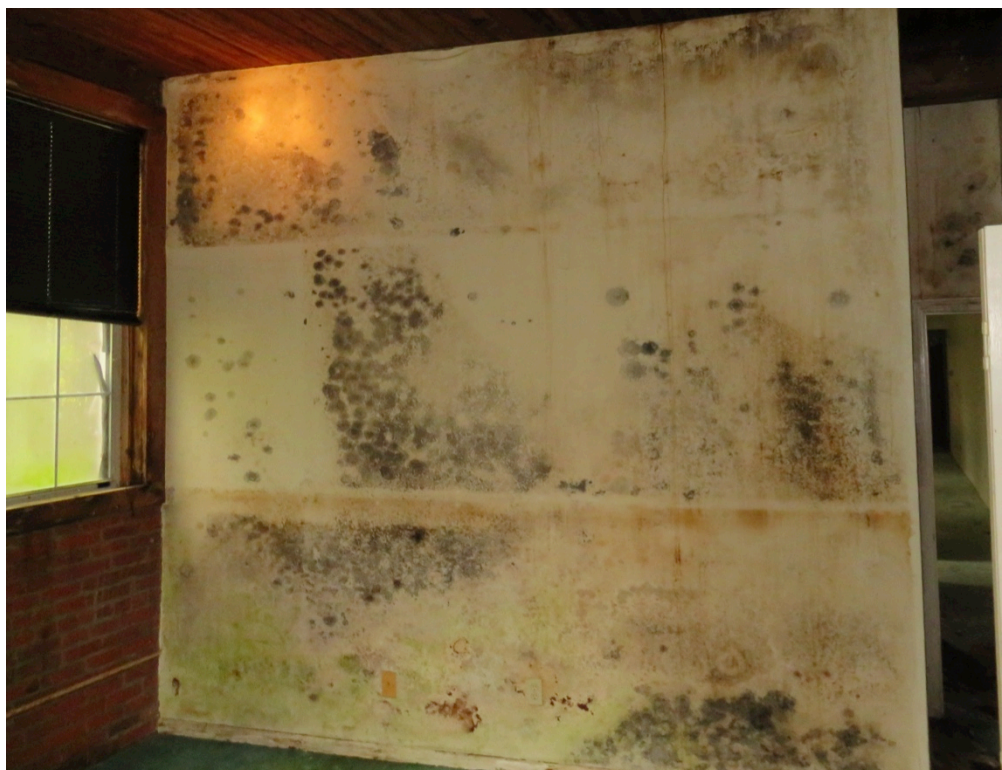
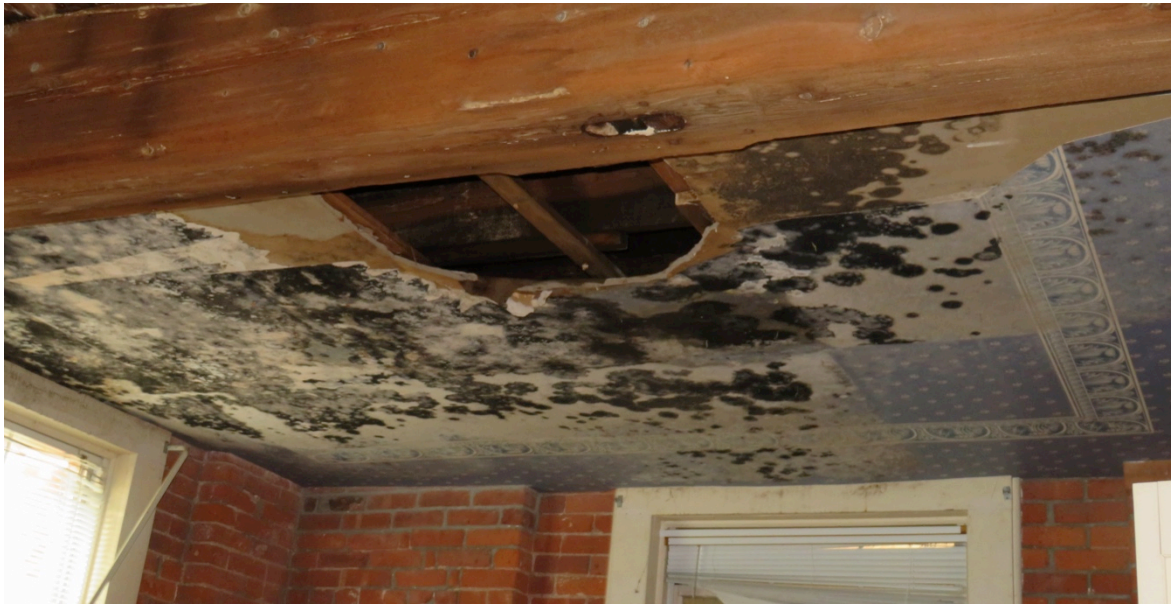
**S-5** Mold. Mold growth is pervasive and extensive throughout the interior of the building. While not experts in mold remediation, *it is clear that all finishes will need to be removed from the building, and existing framing treated with a boric acid spray or other similar medium for killing the mold.* Sources of moisture for the mold are likely roof breaches, as well as moisture absorbed at ground level through the masonry walls due to rainwater leaders discharging at the perimeter of the building, and moisture retained by vegetative growth on and around the exterior walls as noted below. Carpet and drywall also hold abundant moisture and create an environment conducive to mold growth.

Images of Typical Mold Growth Found throughout the Building

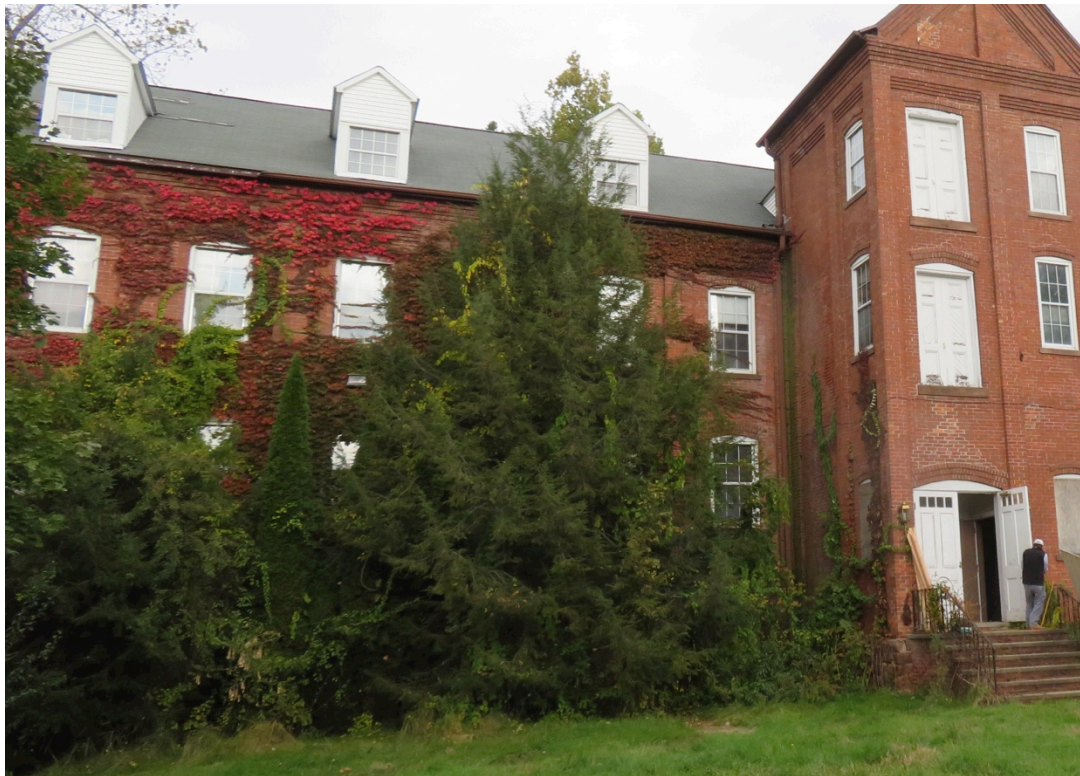
- S-6** General Vegetative Overgrowth on Exterior. Vegetation on the exterior has grown on the building (ivy) and alongside it; these elements provide a source of water and moisture within the masonry walls that has likely fueled the mold on the interior. In addition, ivy has the ability to root into mortar joints and other crevices in walls causing accelerating aging and deterioration of these materials. *We recommend that the vegetation be removed from the walls and perimeter to reduce this source of moisture and facilitate better air flow.*

Images showing Vegetative Growth

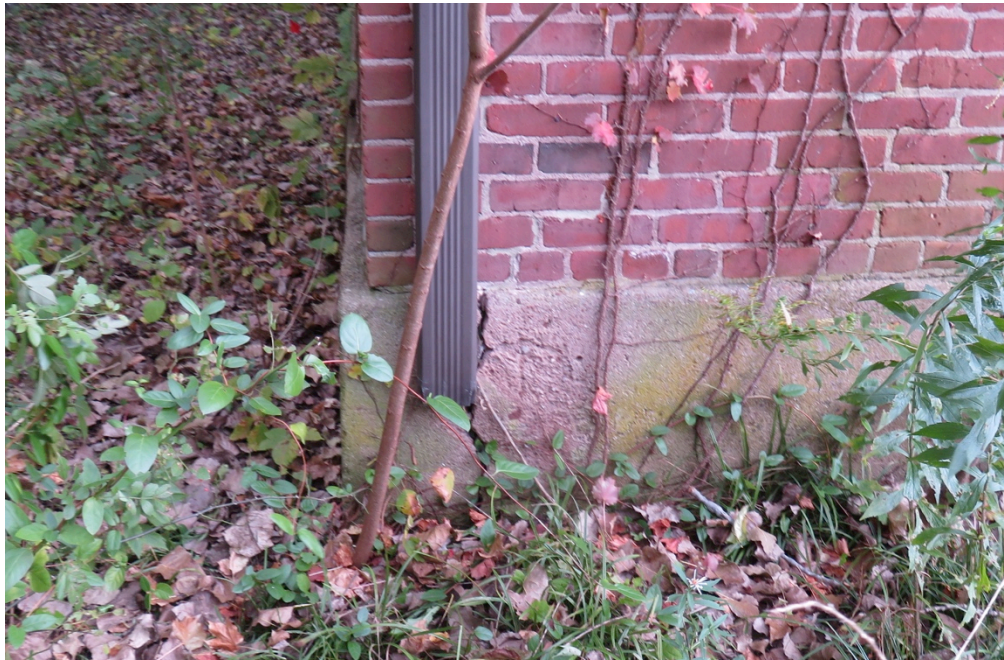
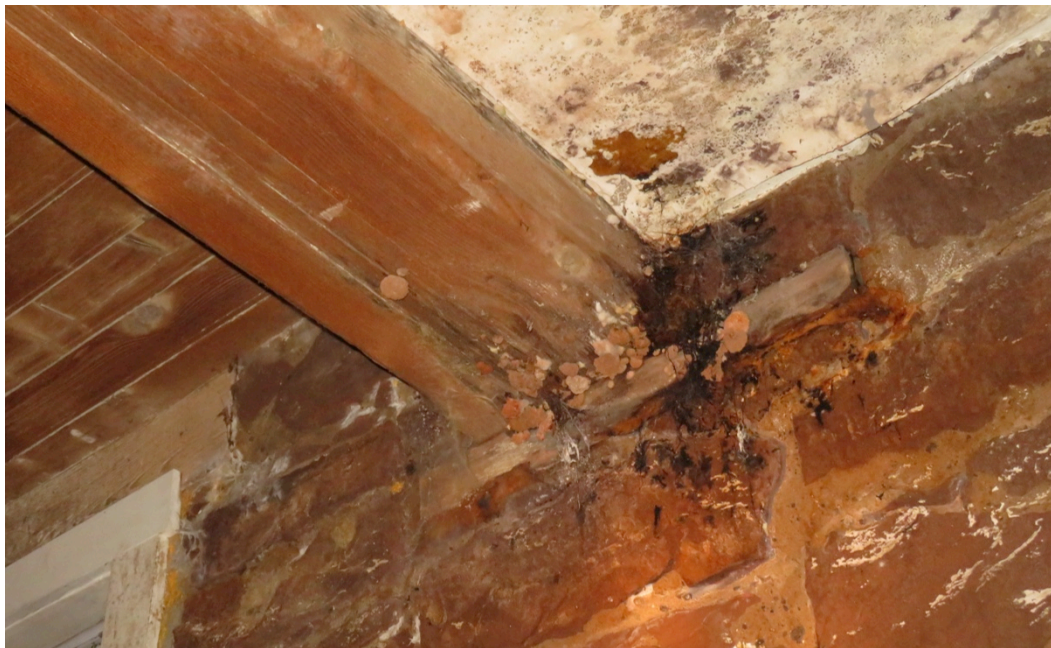
- S-7** Rainwater Leaders Discharging at Foundation. A number of rainwater leaders appear to be discharging right at the foundation wall leading to probable water and moisture infiltration into the masonry walls and basement. At least one beam at the first floor level was observed to be actively growing fungus and may have compromised the integrity of the structural wood; *deteriorated beams will require reinforcement and/or replacement. Rainwater leaders should be extended to discharge and drain away from the building. In all likelihood, the roof drainage system in general is compromised due to lack of maintenance and general age, and will need to be replaced.*

Images showing Truncated Rainwater Leader and Fungal Growth on Beam
