EAST WINDSOR WATER POLLUTION CONTROL AUTHORITY

MAY 2010 COLLECTION SYSTEM MAINTENANCE

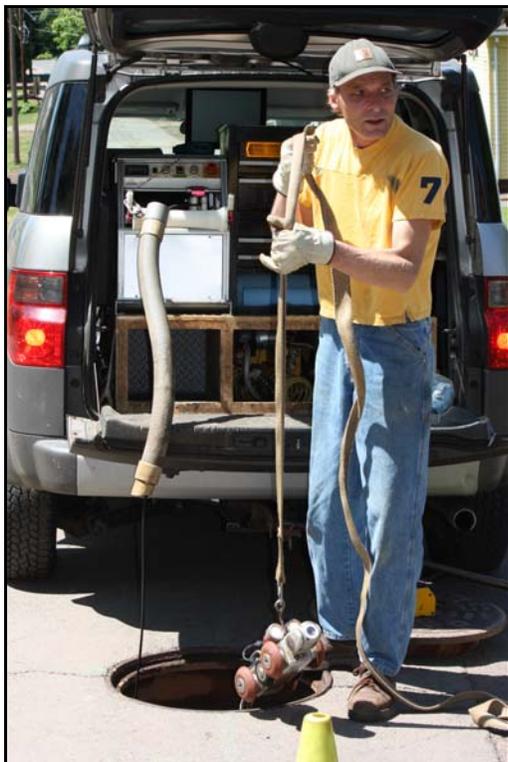
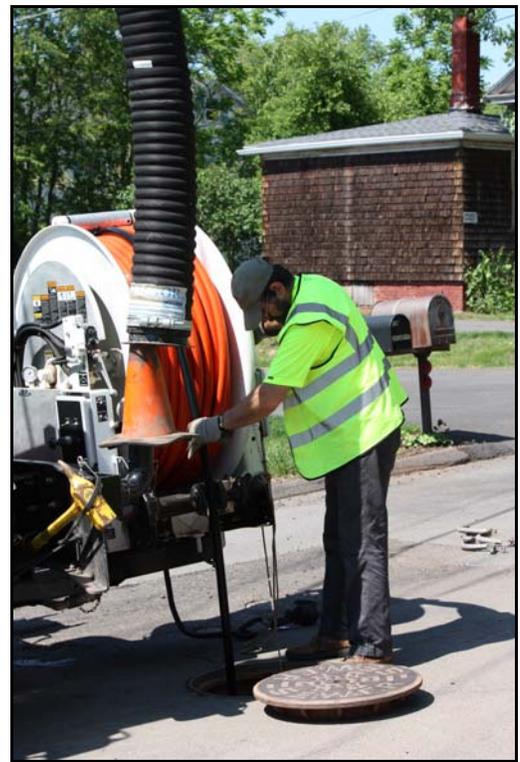
The complete length of Pleasant Street was inspected. The system consisted of 8" clay sanitary sewer pipe. What was found consistently throughout this length of pipe was a series of minor sags and offset joints. Severe roots are visible blocking the line at several sections. There is broken pipe at a few locations. Toward North Main Street severe grease buildup is evident within the line.

Photos from Mobile Robotics, Clockwise from upper left: Severe Roots. Severe Grease and Broken Pipe.

Plant Operators were able to use the visual provided by the camera, as well as the experience of Charles Brown of Mobile Robotics, to flush and cut through much of these sections of pipe. Knowing what you are up against allows our operators to choose the correct head for the flushing mechanism. Having this knowledge also gives them the confidence to send in the root cutter, something which is frowned upon without first "seeing" the pipe.

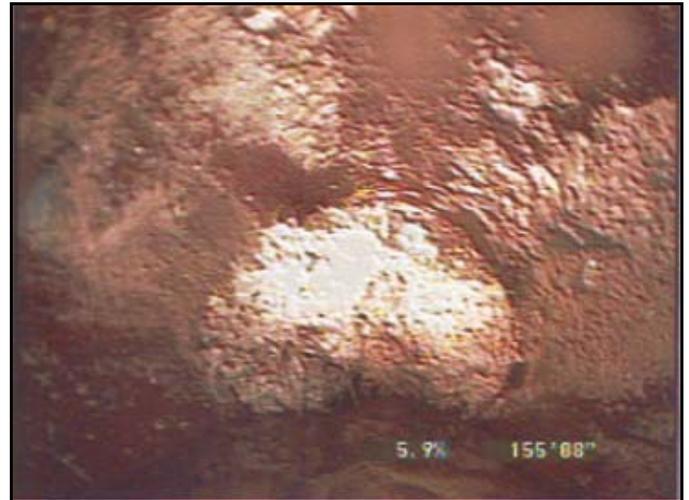
The section of sanitary sewer line from the intersection of Pleasant Street south along North Main Street has been an ongoing issue for us. This was revealed to be 10" clay sanitary pipe. Unfortunately, severe grease, roots and debris were seen within the first 50' section, with the camera unable to continue within this section without more thorough cleaning. This is a 600' run without an intermediate manhole. Useful information gathered thus far includes the need for an additional manhole at some date, along with the warning to not use the root cutter on the jet flushing mechanism until more of the line can be viewed. The fear is that by cutting "blind", we could end up plugging the line downstream as we would not yet know what the condition of the pipe is.

Despite being temporarily stopped from camera work on this section, our staff continued to flush and break down grease throughout the line in preparation for a return trip from Mobile Robotics. It may not happen overnight, but within time we hope to have a complete and better understanding about what exist "underground" in East Windsor's collection system.
