EAST WINDSOR WPCA

COLLECTION SYSTEM MAINTENANCE

VERIFYING LATERAL SEWER LINE CONNECTIONS ALONG SOUTH WATER STREET

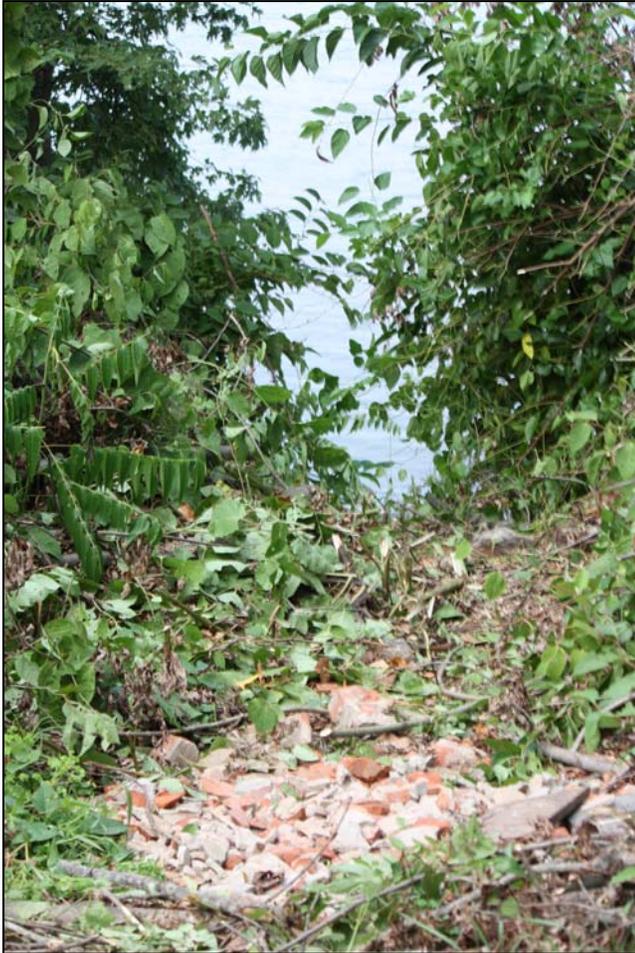
Gaining access to the discharge pipe included cutting a path through the brush along the Connecticut River bank.

Interestingly, the low level of the Connecticut River allowed this lateral to “appear”. Under normal flow conditions, it would be difficult to have witnessed this problem, helping us understand why this issue had not been reported before.

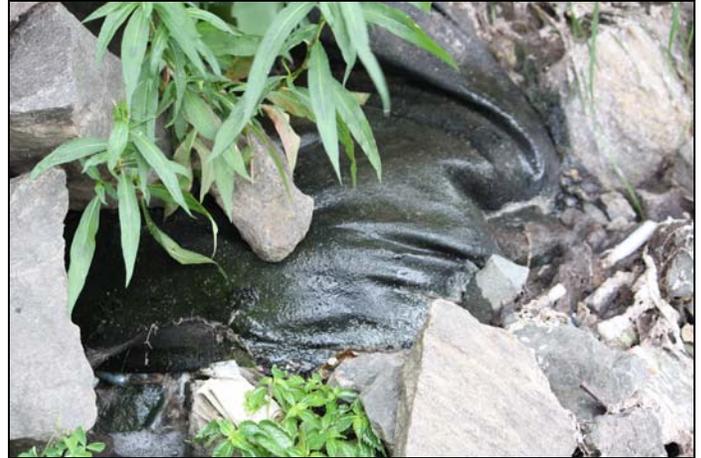
Discharging debris along river bank

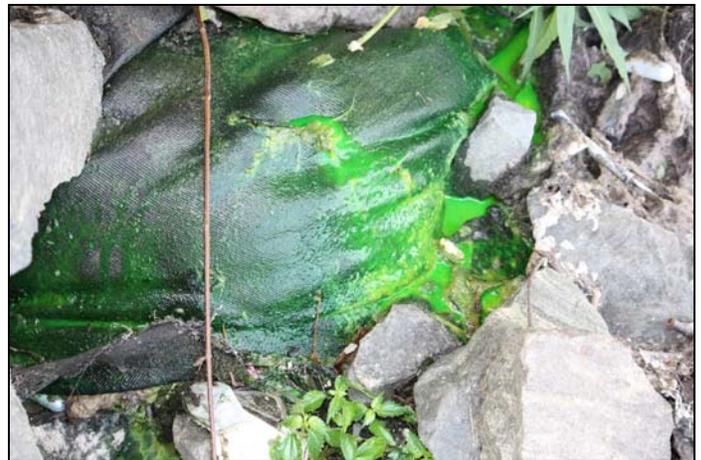
Green Dye verifies we have solved the mystery

The piping in the basement lined up with the discharge pipe along the river bank. We dye tested this home and within minutes we were able to verify that this home's sewer lateral was not connected to the sanitary sewer.

"...Based on a complaint and your department's due diligence, a sewer overflow from 124 South Water Street was found to be discharging into the Connecticut River. As discussed, if the property owner cannot arrange the funding to disconnect the overflow pipe and connect into the sewer main, it would be advised that the town take on the project, with the owner's permission, or through a court order.

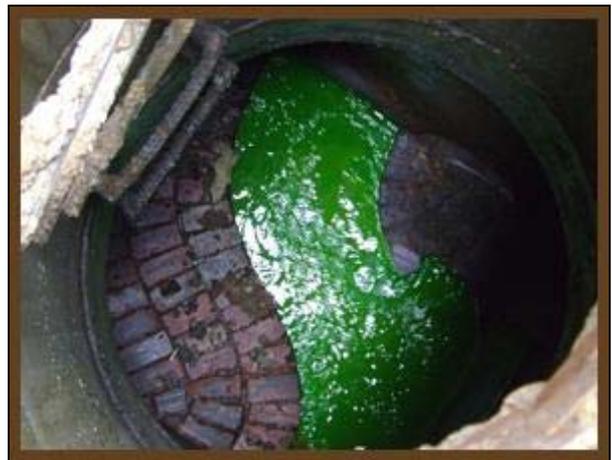
A sign that residential discharge is reaching the sewer line
